Missouri Land Development

February 3, 2003

The following are the results of the seven test holes that were drilled on the east side of Highway 67 to test for depth of refusal and hardness of rock.

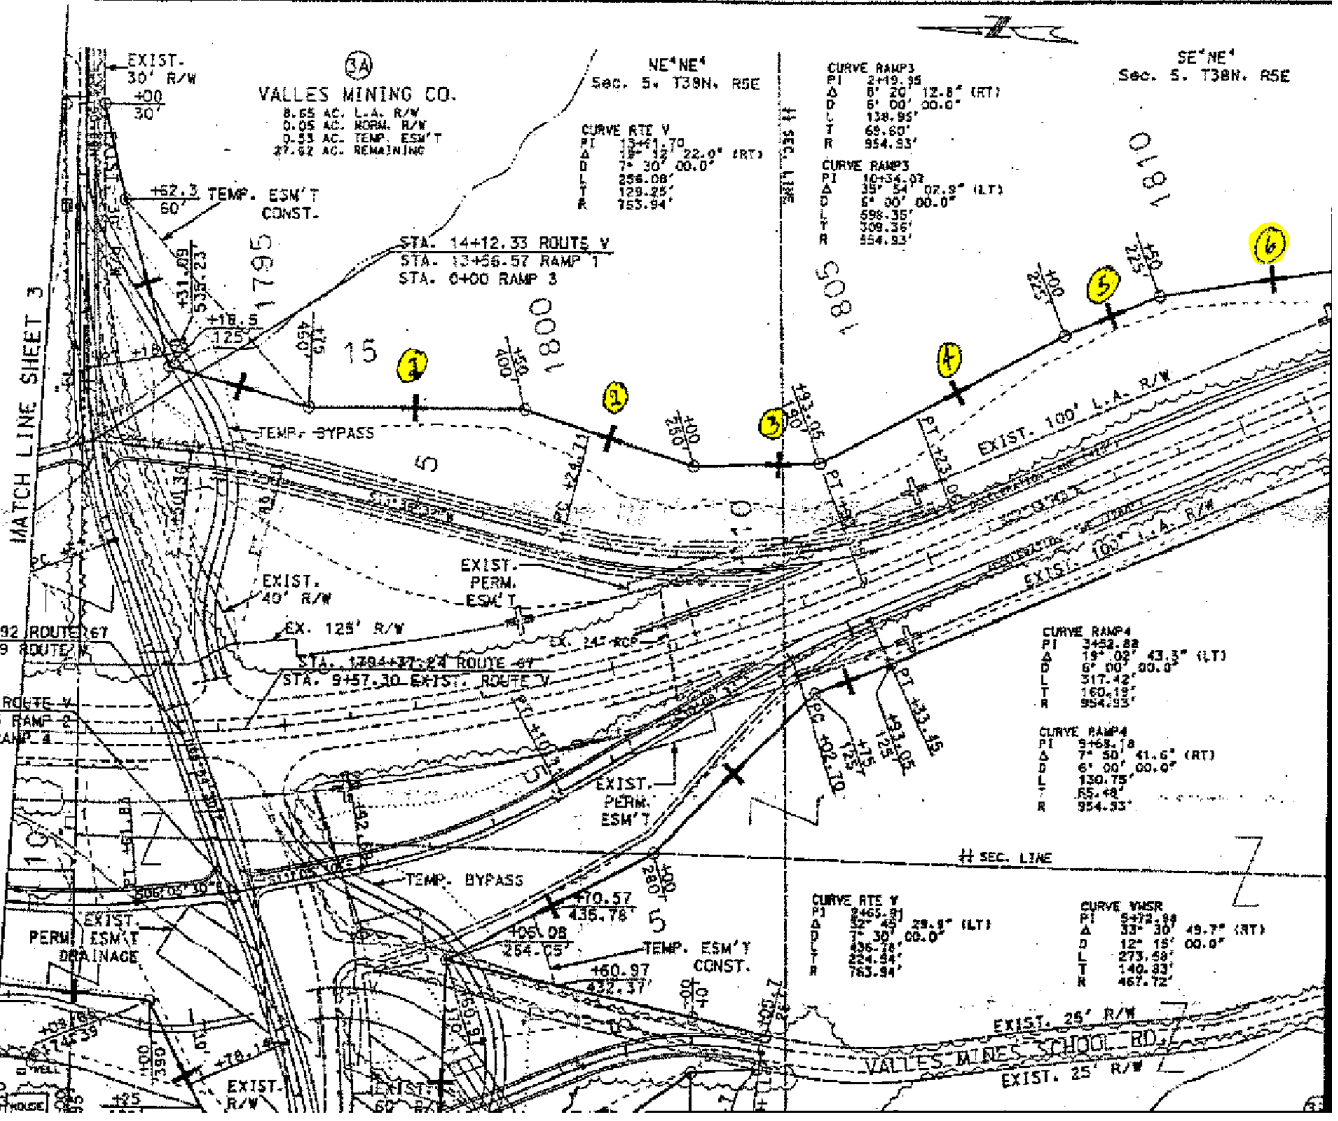
- Hole 1: 4' of overburden, good rock to 24' plus.
- Hole 2: 6 1/2' of overburden, good rock to 24' plus.
- Hole 3: 4' of overburden, good rock to 24' plus.
- Hole 4: 5 1/2' of overburden, sandstone to 15', better rock to 22' plus.
- Hole 5: 6 1/2' of overburden, sandstone to 10', good rock to 24' plus.
- Hole 6: 7' of overburden, sandstone to 9', good rock to 24' plus.
- Hole 7: 5 1/2' of overburden, sandstone to 20' plus.

These test holes are marked on the drawing that you supplied for me. Thank you for the work.
